JOB NO. 2433-0010

2020 CAPITAL IMPROVEMENT PLAN

RECLAMATION DISTRICT 1000

AUGUST 2020

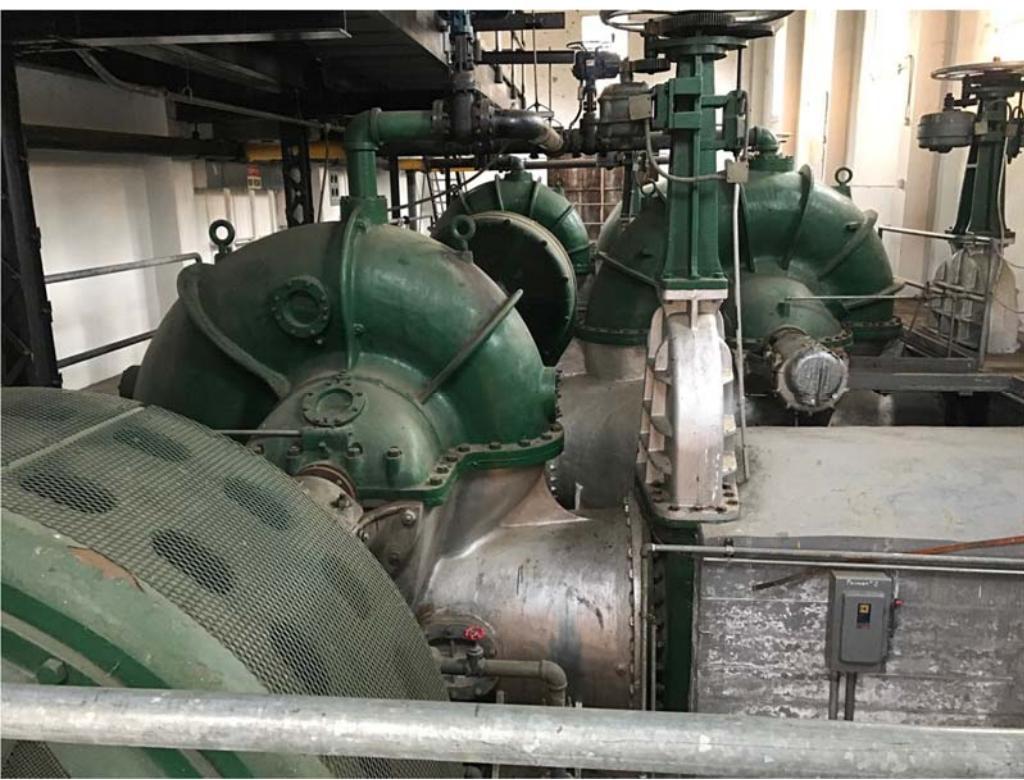
Figure 1 - Pumping Plant 1A Pumps

The pumps are generally believed to be in good shape, showing no visible abnormal wear. Piping, where visible, appears to be in good condition. However, the station has not been operated in at least 10 years, so its ability to serve as a backup system is not assured.

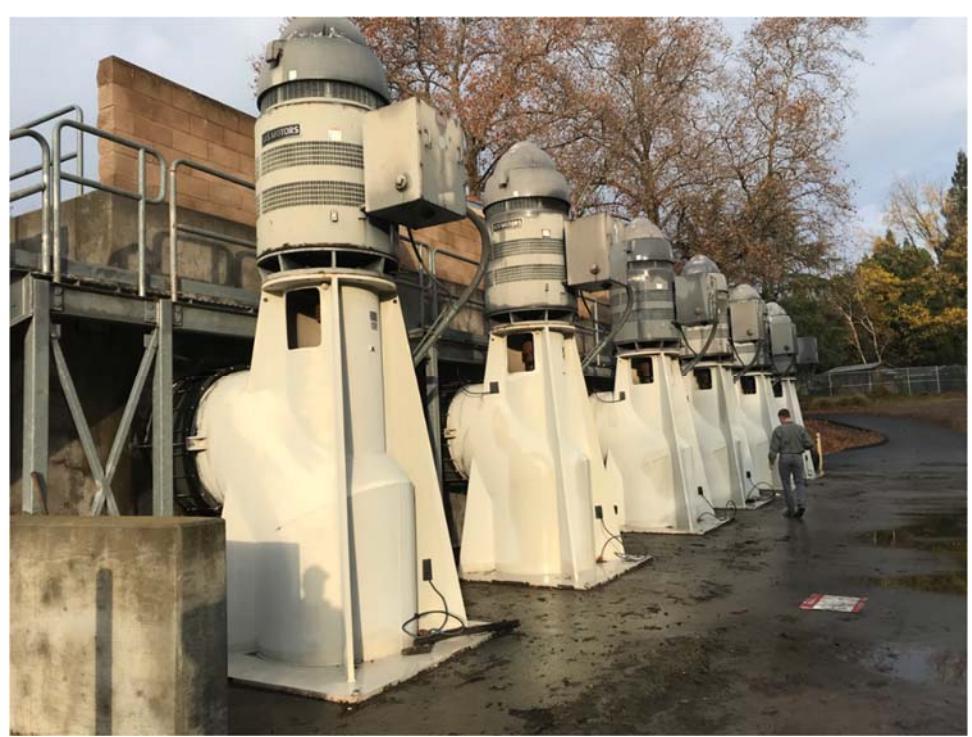
Figure 2 - Pumping Plant 1B Pumps

These pumps and visible pipe are in good condition, and are regularly maintained by the District. The intakes to these pumps are screened with automatic bar screens shown in *Figure 3*.

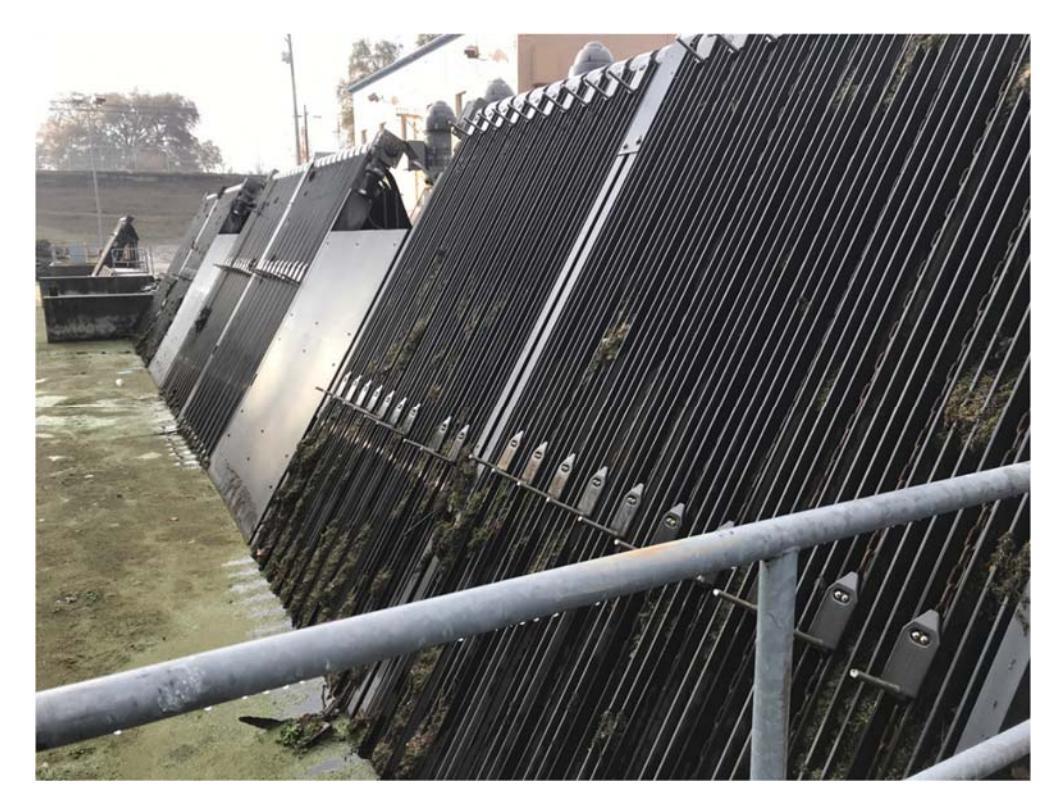
Figure 3 - Pumping Plant 1B Intake Screens

The pumps discharge over the levee adjacent to Plant 1 into separate welded steel pipes to the Sacramento River through a concrete outfall structure fitted with flap gates. Siphon breaker valves are installed near the top on the water side. We understand that the US Army Corps of Engineers (USACE) is evaluating the existing tunnels as part of the Natomas Levee Improvement Project (NLIP) and will issue a report on their condition in upcoming months. Any improvements to the tunnels are assumed to be funded under the NLIP.

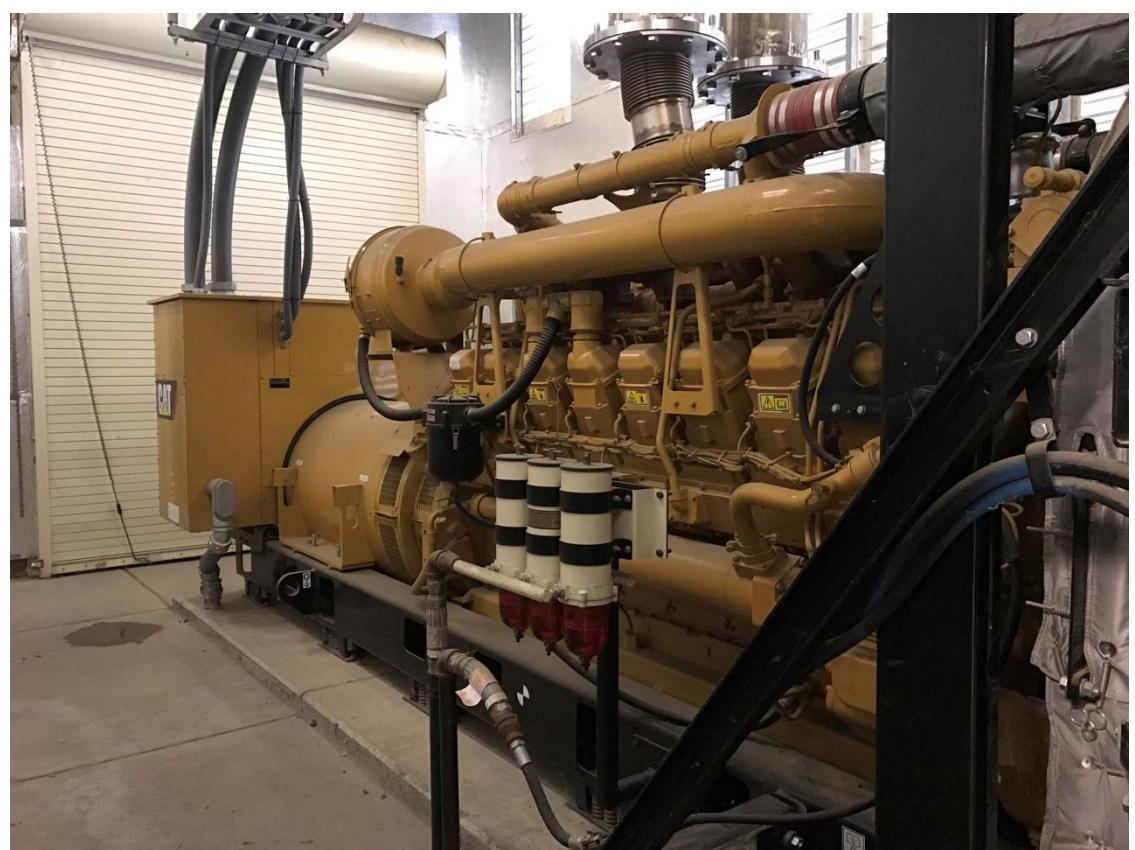
Figure 4 - Pumping Plant 1B Generator

In 2012, a diesel generator was installed inside the plant building. The tankis relatively limited in capacity. With all the pumps running, the generator can support the plant for approximately 8 hours of runtime.

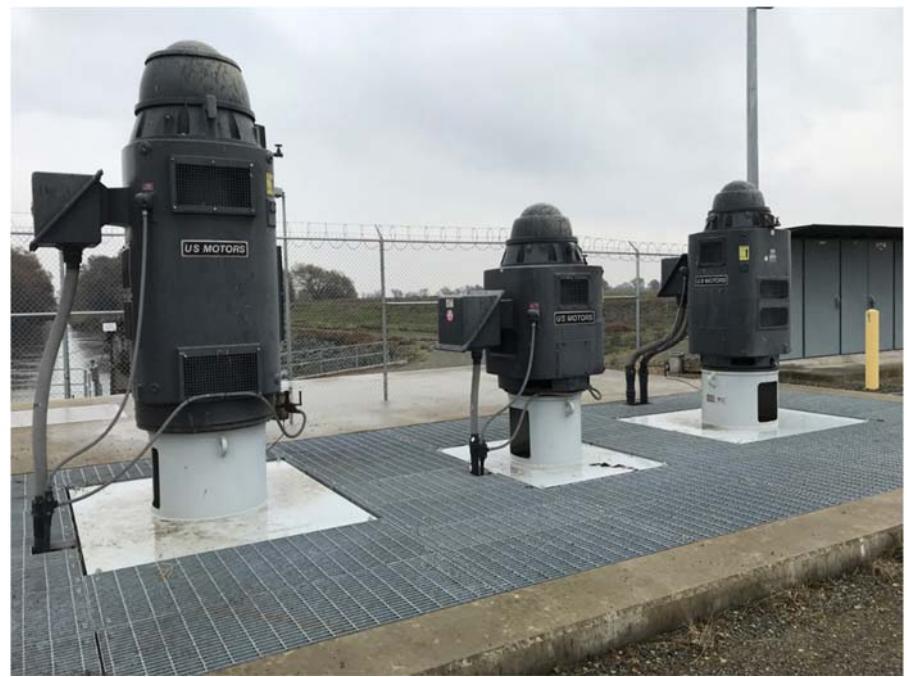
Figure 5 - Pumping Plant 2 Pumps

Like Plant 1, Plant 2 has the same automatic bar screens operating with chains. Plant 2 also has connections for a portable generator, should the need arise. With the latest reconstruction, cathodic protection was added for the pumps' discharge pipes. Due to the recent reconstruction, everything at Plant 2 is still in excellent condition.

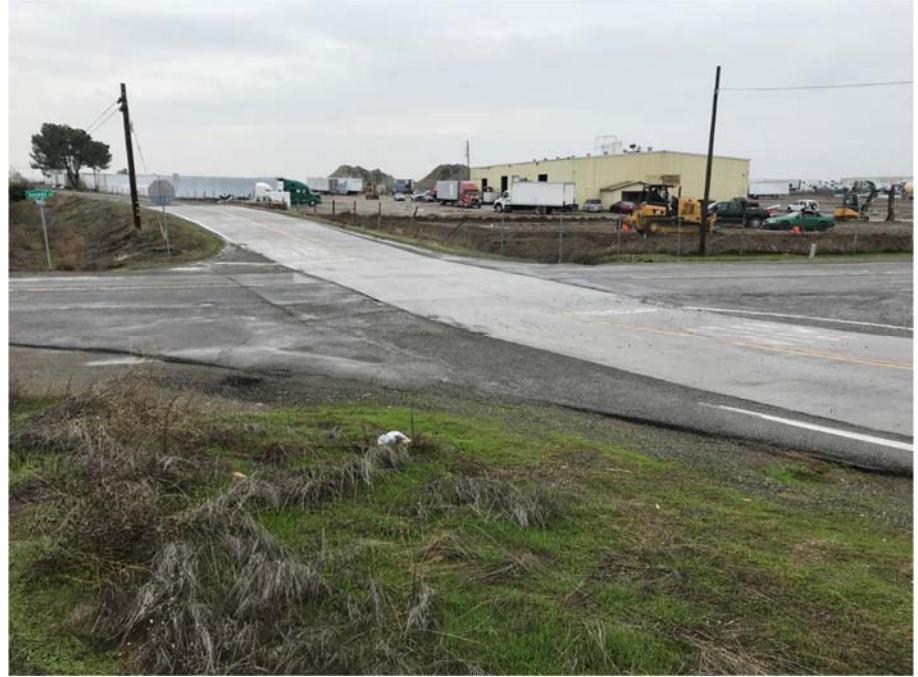
Figure 8 - Sankey Gap

<u>Operations and Maintenance</u> In the northeast portion of the Natomas Basin, there is a significant gap in the levee, named the Sankey Gap, shown in *Figure 8*. The gap is vulnerable to high waters in the PGCC, and should be considered for closure, either in emergency situations with material staging areas, or a permanent construction solution. Our understanding is that to be closed, capacity in the upper reaches of either the NEMDC or Natomas Cross Canal would have to be significantly augmented to prevent upstream flooding in the PGCC when the water would otherwise flow through the gap. The Sacramento Bypass and Fremont Weir widening may significantly decrease the likelihood of stormwater entering the basin through the Sankey Gap and thus the value of any protection measures.
