JOB NO. 2433-0010

2020 CAPITAL IMPROVEMENT PLAN

RECLAMATION DISTRICT 1000

AUGUST 2020

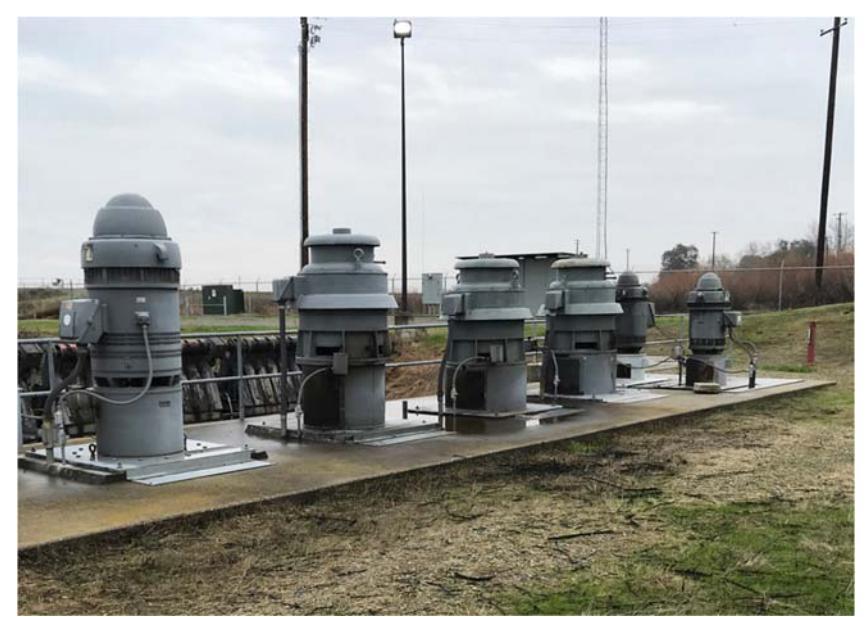
Figure 6 - Pumping Plant 3 Pumps

There are four (4) vertically-oriented mixed-flow drainage pumps, two (2) small irrigation pumps, and one (1) bay for future pump installation in Plant 3 located outdoors, with the electrical components housed in a building adjacent. The pumps are shown in *Figure 6* below.

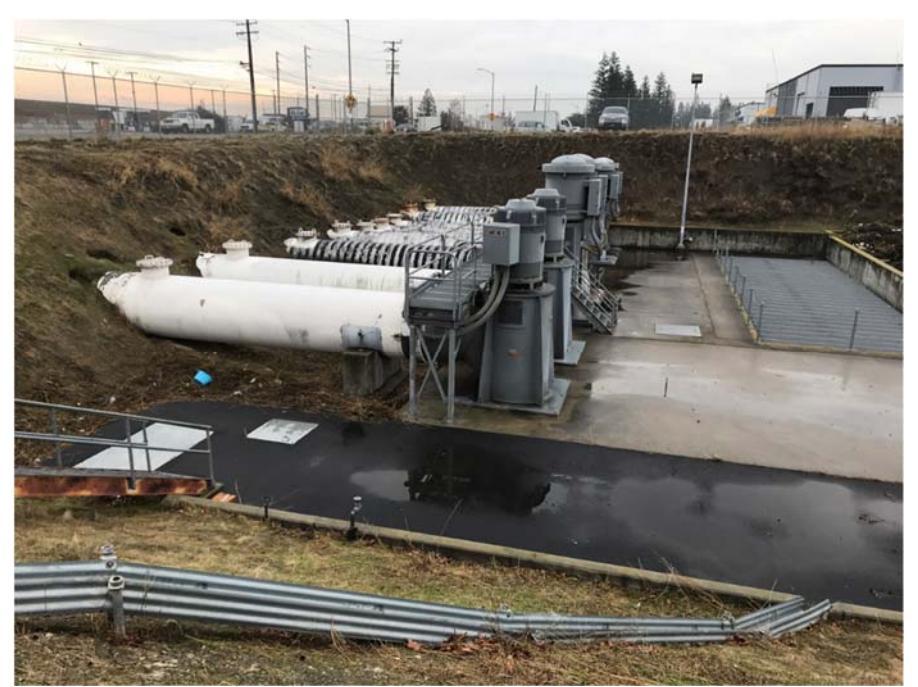
Figure 7 - Pumping Plant 8 Pumps

There are nine (9) vertically-oriented mixed-flow pumps, with two of them being redundant large pumps, located outdoors. These pumps are shown in *Figure 7* below.
